International Journal of Contemporary Research In Multidisciplinary

Case Study

Joshimath: Consequence of Human Disaster: A Case Study

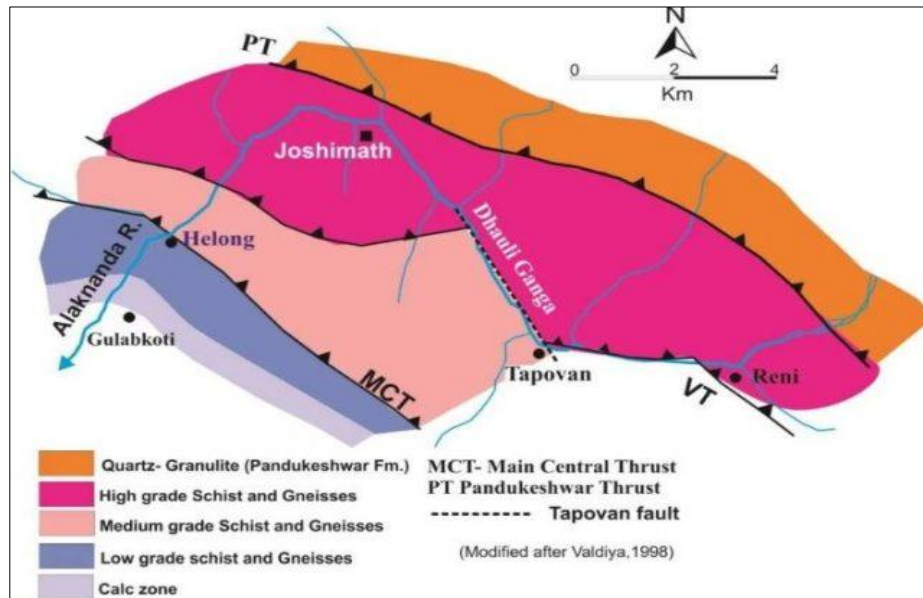
Figure 1: Geological Map of Joshimath and Surrounding Areas

The Town is located in Seismic Zone V, an area of unstable geology. It is located close to the Tapovan Fault, north of the Main Central Thrust (of the Himalayas). Joshimath is close to the Vaikrita and Pandukeshwar thrusts. One of the things that make it prone to subsidence is its proximity to a fault.

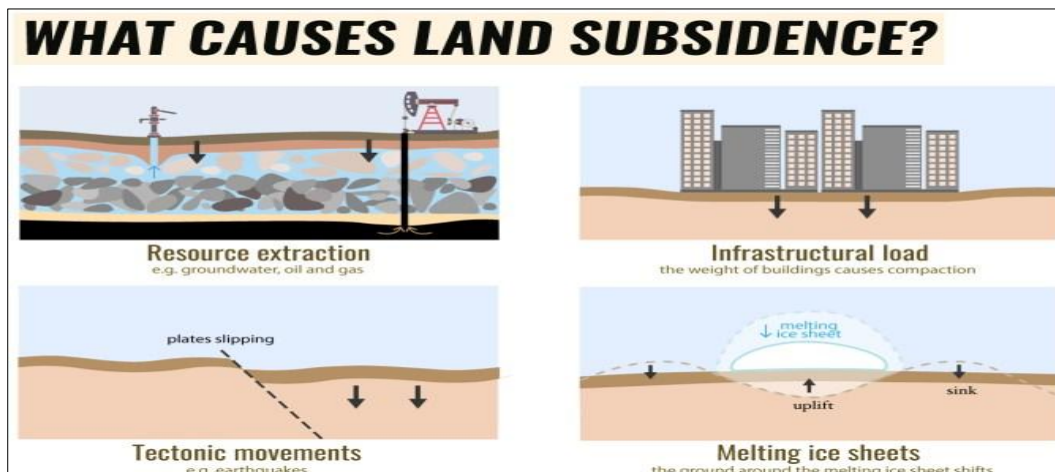
Figure 2: Causes of Land Subsidence

The National Oceanic and Atmospheric Administration (NOAA) define land subsidence as the sinking of the ground as a result of the movement of subsurface materials. The Earth's surface may gradually settle or suddenly begin to sink, which causes subsidence. In general, resource extraction—the process of pumping, cracking, mining, or otherwise removing water,

oil, natural gas, or mineral resources from the ground—causes subsidence; Natural causes include things like earthquakes, soil compaction, glacial isostatic adjustment, erosion, the formation of sinkholes, and the addition of water to fine soils. Infrastructure loads include heavy loads that are more than what the underlying soil can support.

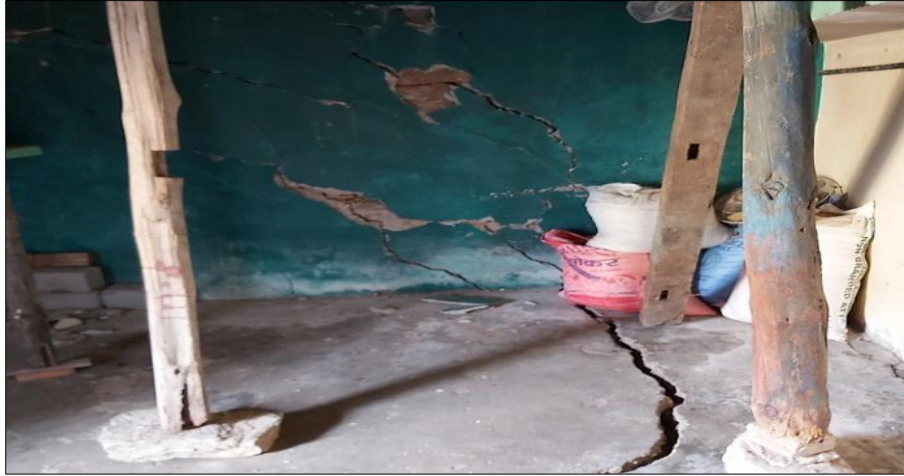
Despite the state government's lack of concern, building fissures started to show more frequently. Hundreds of homes had split walls and floors by the beginning of December 2022. Many families began using wooden poles to support their roofs. Others completely departed Joshimath out of fear.

Fig 3: Cracks In A House In Joshimath

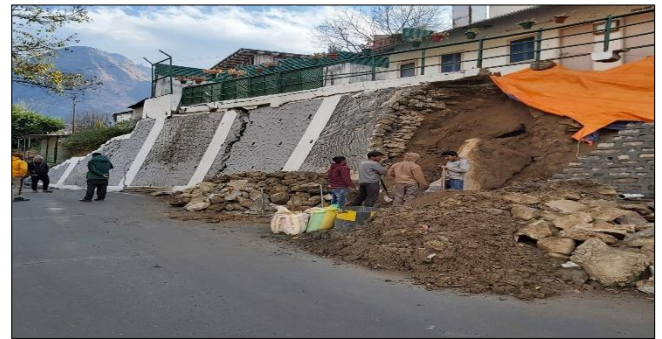
On the evening of January 2, a significant water discharge and subsidence within the JP Hydro colony prompted the state and federal governments to take action. 561 buildings had suffered major damage, the Chamoli district government reported on January 4th. Orders were given to the NTPC, BRO, and other contractors to stop all work after a chakka jam (road blockade) in the town on January 5 (Sethi 2023a) ^[5].

Fig 5: Fissures in boundary wall of J.P. block of hydro colony
